Manhole Inspection Summary

Manhole # S09UU_006MH

Insp Date: **4/5/07 2:01 PM**

Location Address: **3305 SPRINDALE AVE**

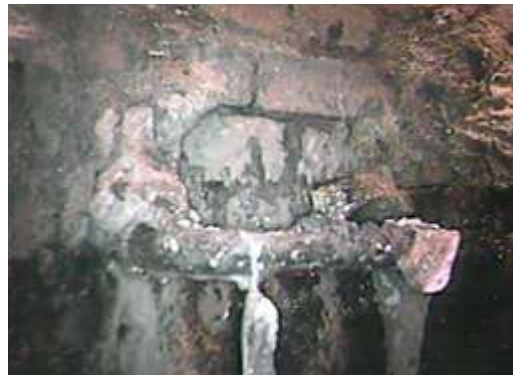
Defect 1

Steps Count: **7** Missing: **0** ☒ **Corroded**

Surcharge ☒ **Evidence Of Surcharge** Depth: **6** (ft.) ☐ Active Surcharge Present

EVIDENCE SURCHARGE AND
CORRODED STEP

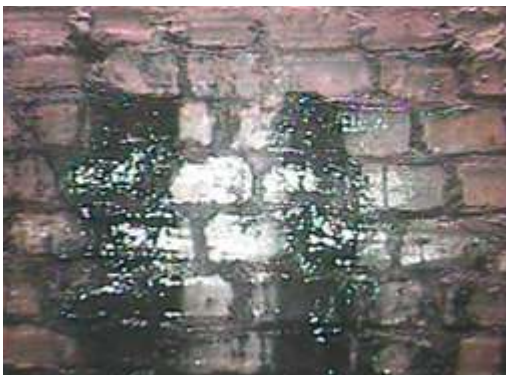
Defect 2

Infiltration: ☐ None ☐ Joint ☐ Cracks ☒ **Mortar** ☐ Roots ☐ Wall

BARREL INFILTRATION

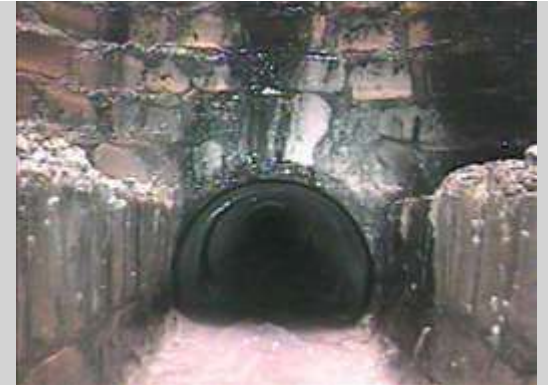
12 O'Clock Outflow

10 in. Circular Gravity Sewer
Pipe Out @ 12 O'Clock

Pipe Height: (in.) Direct
Pipe Material: **Clay** ☐ Pipe Lined
Invert Depth: **12.75** (ft.) Flow Characteristics: **Fast**
Deposits: ☒ None ☐ Mud ☐ Sludge ☐ Debris ☐ Grease
Silt Depth: (in.) Deposits Extent:
Infiltration: **None** Pipe Seal Cond: **Sound**

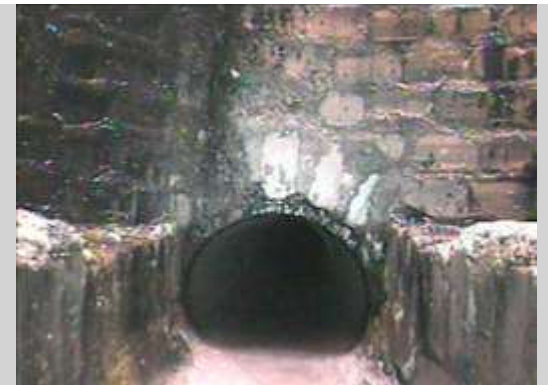
6 O'Clock Inflow

10 in. Circular Gravity Sewer
Pipe In @ 6 O'Clock

Pipe Height: (in.) Direct
Pipe Material: **Clay** ☐ Pipe Lined
Invert Depth: **12.55** (ft.) Flow Characteristics: **Fast**
Deposits: ☒ None ☐ Mud ☐ Sludge ☐ Debris ☐ Grease
Silt Depth: (in.) Deposits Extent:
Infiltration: **None** Pipe Seal Cond: **Unknown**
